USING ELWd IN REDMOND'S WILLOWS CREEK PROJECT

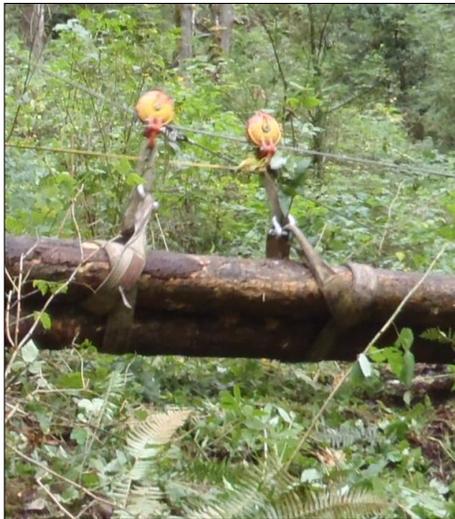
Cable system using straps, blocks & shackles

ELWd provides a versatile alternative to large wood when working in sensitive and remote locations. The project site, on upper Willows Creek, is located in a steep ravine, and is difficult to reach with standard construction equipment, like tracked excavators. The individual logs were instead, transported from the top of the ravine to the stream channel, using a griphoist and cable system. Once the logs were at the stream, they were maneuvered into place by hand or by using simple tools, like peaveys, and timber carriers.

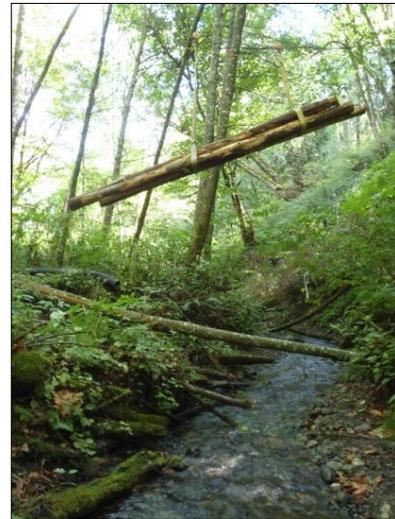
Logs transported on cable system from top of ravine, down to the stream

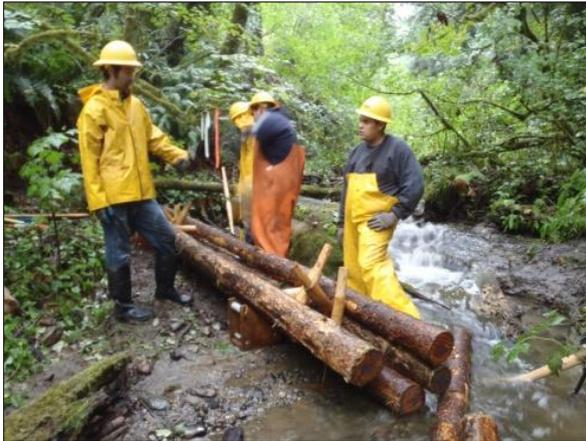
ELWd #1 being assembled by WCC crew

Anchoring of the ELWd relied on the diameter and length of the assembled structure to prevent it from mobilizing and moving downstream. The ELWd structures were sized to be 2-3 times the bankfull width of the stream, and the structure diameter greater than or equal to the bank full depth. The size of the assembled ELWd structures mimicked key pieces, allowing additional logs to be racked and built off them. Branches and smaller diameter logs were added to each ELWd to increase the habitat value.

The inside of the ELWd structures were lined with a coir fabric and filled with cobble and gravel on the bottom, and soil on the top, and then planted with native vegetation. The riparian was also planted with native trees and shrubs to help stabilize eroding streambanks, restore the forest to pre-logged condition and to provide future large woody debris to the stream.

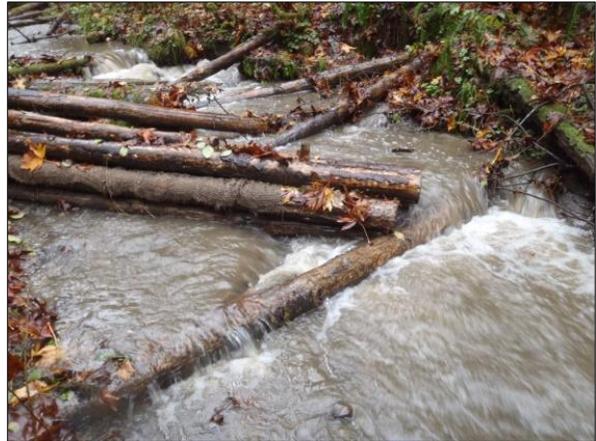
ELWd #1 during Willows Creek storm flow

During recent fall storm flows, the ELWd and other log structures help aggrade the channel by slowing the stream velocity and holding sediment upstream of the structures. The addition of woody material also helped to scour pools, sort sediment and protect streambanks from erosive flows. Pre-project channel cross-sections, observed fish-use and photo points provide a base-line to compare future conditions and measure the long term success of the project.

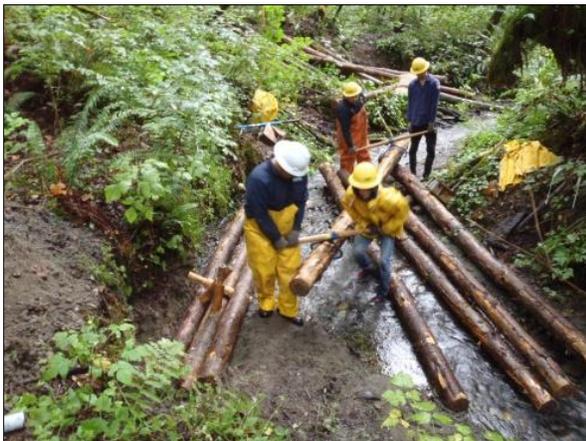
ELWd #2 being assembled by WCC crew

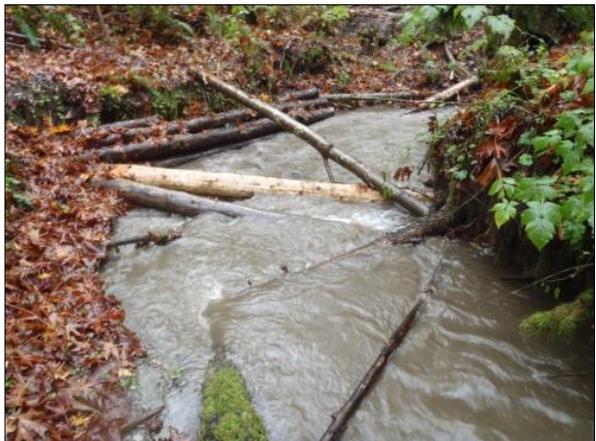
ELWd #2 during Willows Creek storm flow
